LOCAL SCOURING AND SCOUR COUNTERMEASURE IN MALAYSIA

ABSTRACT

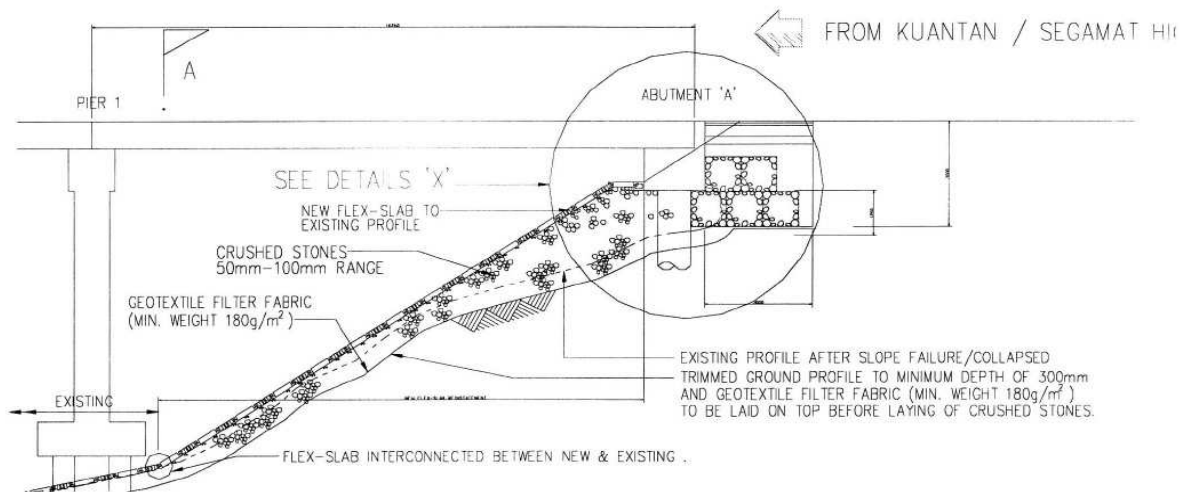
Figure 1 : Sectional View of Bridge Abutment at Pukin River Bridge

Approximately two years after actions were taken to remedy the failure of the slope embankment, another flood in June 1995 has further aggravated the slope embankment at one of the bridge abutments. The personnel from the Bridge Unit of the Public Works Department Malaysia and the District Office had carried out a detailed joint inspection after the flood to investigate the defects at the bridge. Observations showed that the slope embankment at the bridge abutment had collapsed partially although the majority of the slabs were intact. They reported that "the flex-slab at the toe of the slope embankment was slightly crumbled". The original manufacturer of the flex-slab system laid in 1993 carried out an independent inspection of the site on June 21, 1995. They reported that the main cause of the failure of the flex-slab system is earth movements due to seepage. It was unfortunate that no detailed information is available on any scouring that may have formed at the toe of the abutment. Hence, one is unable to determine whether there is a correlation between failure of the flex-slab system along the embankment and scouring that could have occurred at the toe of the abutment.

Figure 1 shows the sectional view of the abutment and the proposed scour countermeasure at Pukin River Bridge. The new slope embankment was completed at the end of 1996. On the day of the site visit (January 4, 2000), the flex-slab system was still in place, and no defects were apparent.

The recommendation by the authority was to reinstate the failed slope embankment to avoid further loss of fill material and disintegration of the flex slab. To that end, the following steps were recommended:

- The existing flex slab at the abutment shall be dismantled and stored at a separate location. The broken slabs shall be removed and disposed;
- The existing ground profile shall be trimmed to a minimum depth of 300 mm and a geotextile filter fabric with a minimum weight of 180 g/m² shall be laid;

- The material loss at the slope embankment shall be replaced with crush stones ranging from 50-100 mm;
- The crush stones shall be compacted to build up the slope to the existing profile in preparation for laying the flex slab; and
- The new slope shall be protected using the flex-slab protection system.

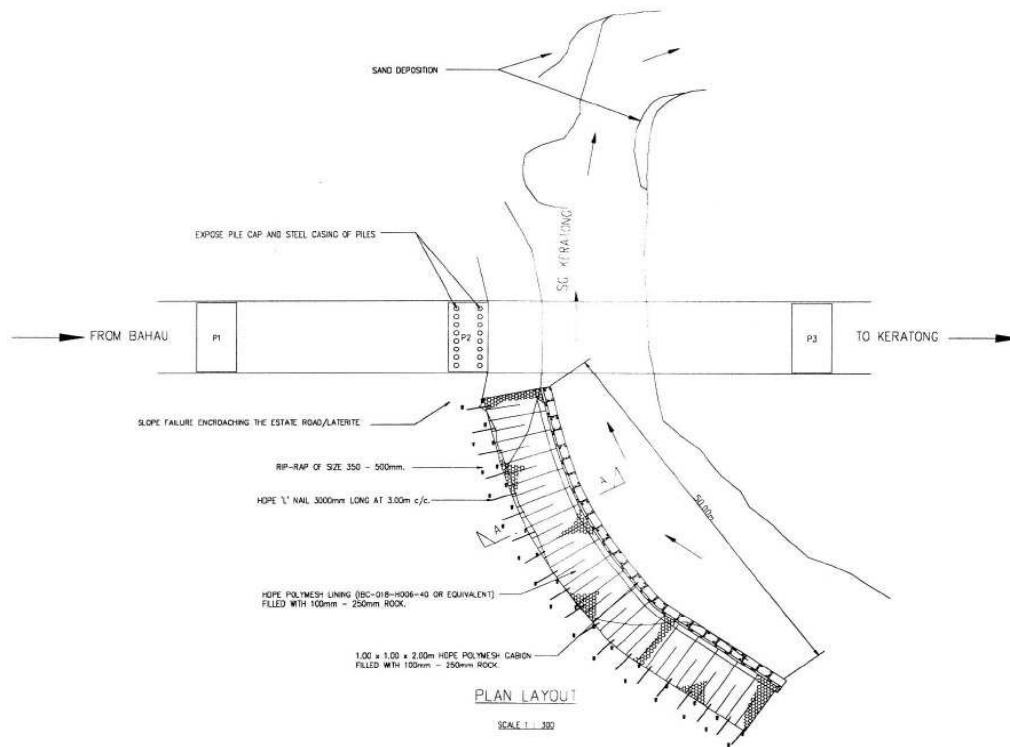
Figure 2 : Plan View of Keratong River Bridge

Keratong River Bridge links the towns of Bahau to Keratong in Pahang, Malaysia. The bridge is located at a curved section of the river, and it is supported on six rectangular piers each with a size of 0.914 m x 8.54 m on a pile cap with a size of 4.27m x 9.14m. Figure 2 shows the alignment of the bridge to the river, and the supporting structures. Pier 2 is located on the outer bend of the river, with its pile cap protruded slightly into the waterway. As such the protrusion will cause local scouring at the toe of Pier 2 (Lim, 1997; Lim and Cheng, 1998). In addition, its location at the bend further aggravates the extent of localized scouring at the abutment.

During a recent flood, severe river bank erosion has occurred, causing slope failure along a 50 m stretch on the upstream bank of the abutment. This realignment of the channel geometry

may have caused the shifting of the thalweg of the channel bed, and thereby directing the main flood flow towards Pier 2. Consequently, the toe of the approach fill slope was eroded, and undermining of the fill material occurred causing slope failure at Pier 2. The result is that the pier pile cap and steel casing of the piles have been exposed, and the flow encroached all the way onto the estate road. The damage can be attributed to the increased velocity of the river flow during the flood and the migration of the channel flow towards Pier 2.

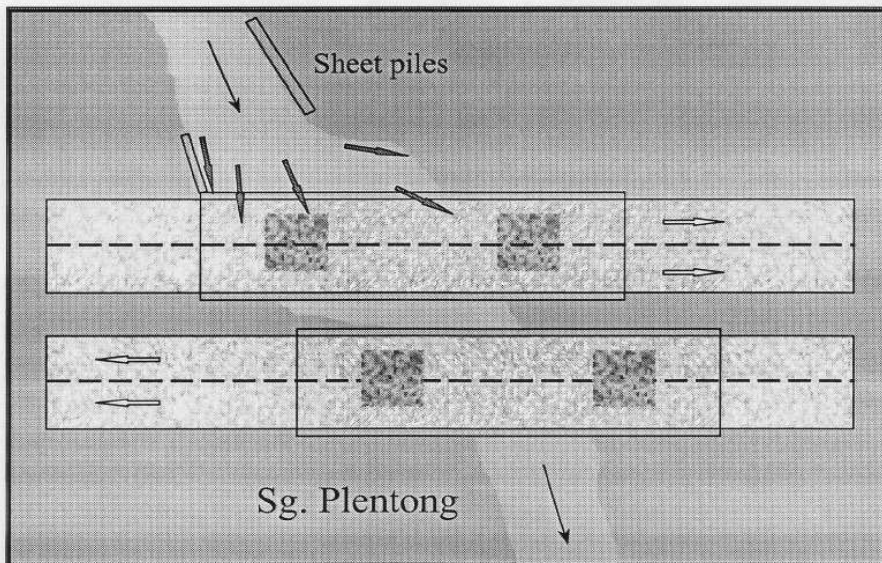
Figure 4 : Plan View of Plentong Bridge

Plentong River Bridge is a dual carriage road linking Johor Bahru to Pasir Gudang Port along Federal Trunk Route 17 in the state of Johor, Malaysia. The bridge, which was constructed in 1983, consists of two separate structures each carrying two lanes of traffic in one direction. The structures comprise a three-span bridge of pretension inverted T-girders, and the length of the spans are 11.25m, 15.75m, and 11.25m, respectively. Two cylindrical bridge piers with diameter = 1.32 m support each of the two structures (see Figure 4).

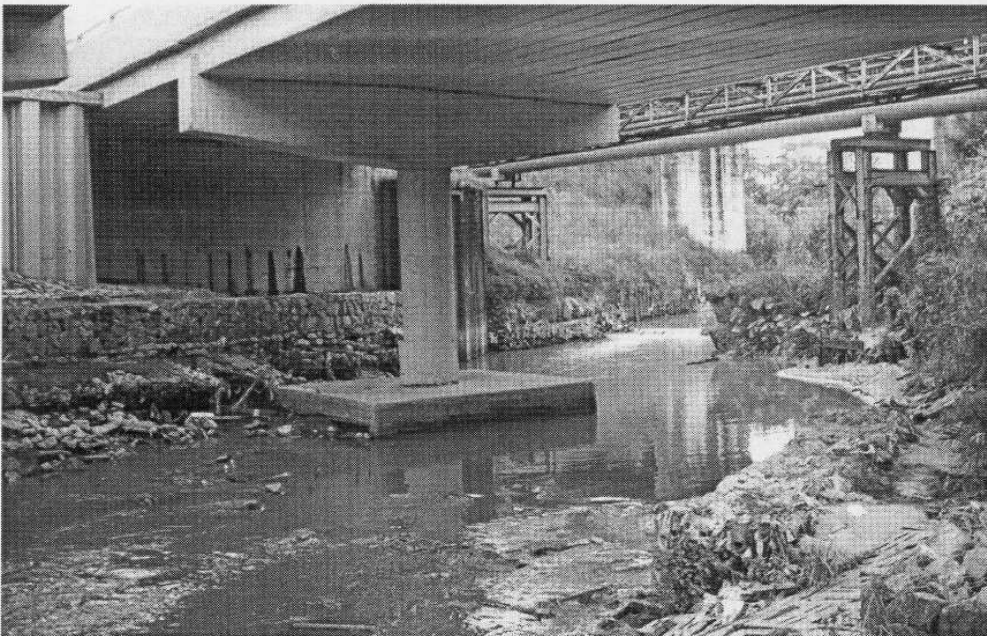
Figure 5 : Plentong River Bridge (flow from top right to bottom left)

Scour problems at Plentong River Bridge were reported very early in the life of the bridge, and sheet piles were used to protect one of its abutments (see Figure 5). However, this countermeasure did not seem to arrest erosion completely. In 1995, the flex-slab system was used as a more permanent solution after the apparent success of the method for Pukin River Bridge. However, this system did not work as anticipated and failed. To arrest further erosion, the District Office of the Public Works Department used gabions and rubble pitching type of protection as a temporary measure (see Figure 6). The scouring problem at this bridge is now continuously being monitored to check that it is not detrimental to the overall safety of the superstructure.

would have been substantial, contributing to the failure of the flex-slab system. This can be seen in Figure 6, which shows that severe erosion has taken place along the abutment, and the flex-slab system on the abutment has collapsed. The photograph in Figure 5 also shows severe scouring at the pier, damaging the flex-slab system on the approach fill slope. It can be seen that the flex-slabs are lying around the site of the pier.

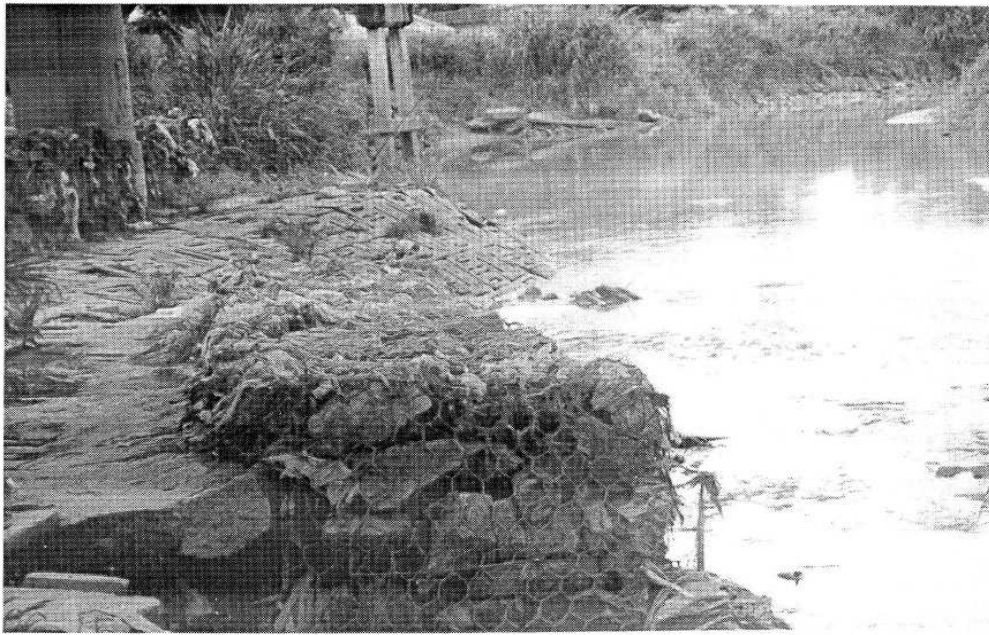
Figure 6 : Use of Gabions as a Temporary Scour Countermeasure at Plentong River Bridge (looking downstream)

On the day of the site visit (January 3, 2000), observations clearly showed that erosion had occurred along the riverbank at the bridge site. Sheet piles and a grade-control structure were apparent on the upstream end of the bridge. The upstream grade-control structure appeared to have re-directed the flow towards the pier and the abutment (see Figure 4). It is envisaged that during flood flows in the preceding monsoon season, scouring at both the pier and abutment
