PERFORMANCE OF DIAMOND SHAPE ELASTOMERIC BEARING PADS IN KUALA LIPIS BRIDGE

Elastomeric Bridge Bearings/Skewed Bridges/Bridge Rehabilitation

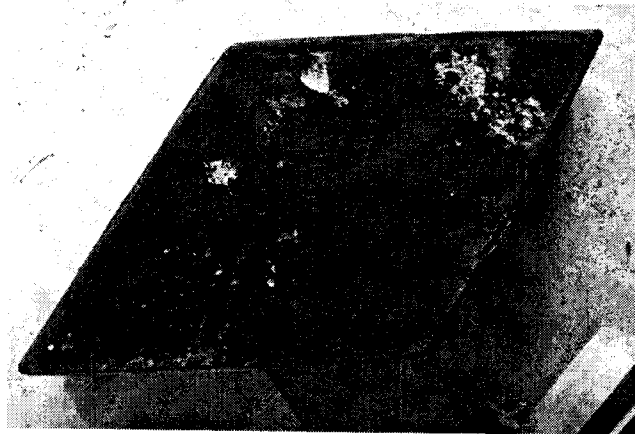
Figure 1 : Diamond Shape Elastomeric Bearing Pad (Plan View)

One unique feature of this bridge is the use of diamond shape elastomeric bearing pads apparently so chosen to tackle the skewing effect of the bridge deck (Figure 1). Bridge bearing pads of shape other than rectangular have never been used in Malaysia.
